An 18th-century timber wharf in Copenhagen Harbour

By LENE HØST-MADSEN

SUMMARY: An archaeological investigation prior to the building of Copenhagen's new Opera House examined an impressive wooden wharf built in the 1780s around Ankerøen, the island on which the Danish navy stored its anchor stocks. When considered with documentary evidence, the excavated structure can be shown to employ a distinctive method of construction, comparable to that used in the so-called 'Hamburg' type of wharf, with a heavy box-like frame fronted with slanting storm posts. It was abandoned by the mid-19th century, when the shape of ships' hulls changed.

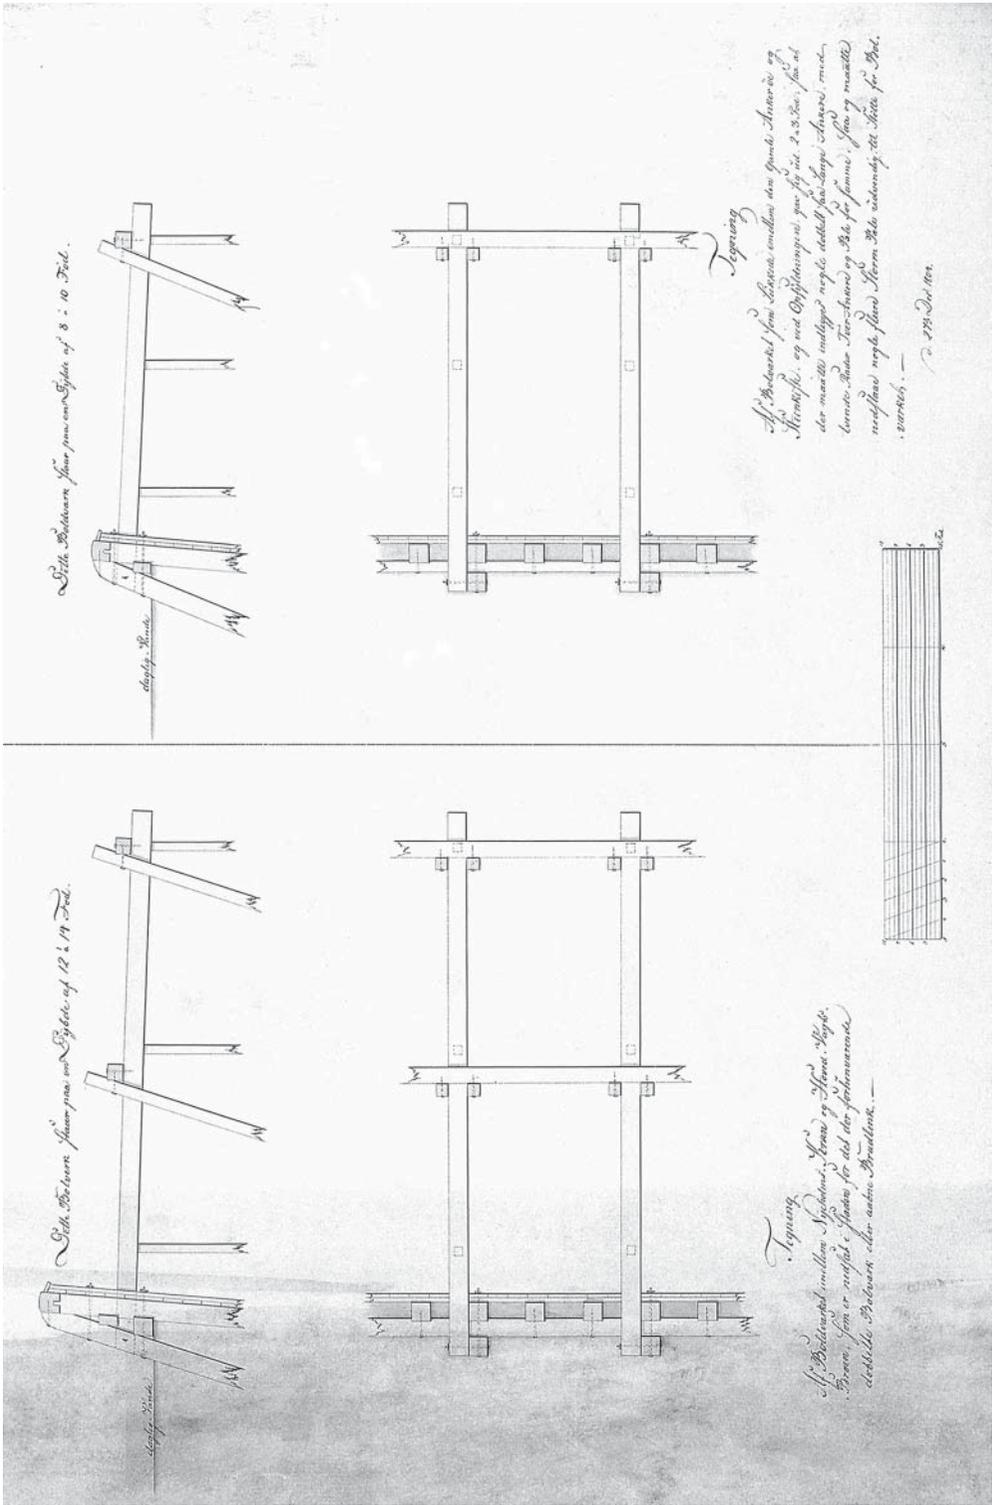
FIG. 3 Copenhagen Harbour. Construction drawing of two types of wharf of 1804 (Danish State Archives, Søetatens Restsamling).

Substantial map evidence and other source material are available concerning the buildings and other structures on Holmen; it has not proved possible, however, to find detailed drawings of the construction or form of Anchor Island. Searches in the State Archives related to Holmen revealed a construction drawing of 1804; it depicts two wharfs in section and in ground plan (Fig. 3). One of them, more sturdy than the other, closely resembles the wharf excavated on Anchor Island (see below). It bears the following description: 'Drawing of the wharf between the Nyholm Crane and the Main Guard Building. The pier has been set in place instead of the previous double wharf or open careening bay'. Above the drawing is added: 'This wharf is situated at a depth of 12 to 14 feet' (i.e. c. 4m below sea level). The other wharf on the drawing is accompanied by the following text:

Drawing of the wharf that enclosed the area between the old Anchor Island and the Stone Trough, and which, when it was filled in, subsided some two to three feet [0.6–0.9m], so that some anchoring timbers of double length had to be set in, with two rows of cross-anchors and posts to support them. Some additional storm posts had to be hammered down on the outside to support the wharf.

Above the drawing it is noted that the wharf stood on the sea bed about 8–10 feet [c. 3m] below sea level. The word 'old' shows that the drawing must be later in date than the construction of the wharf on Anchor Island; 'the Stone Trough' must refer to Ballast Island. The information that the wharf subsided when the infill was added, and that it had to be strengthened, is interesting. This may mean that the construction drawing (Fig. 3) was used to illustrate both a viable and an unsound type of wharf.⁸

Comparison of the wharf on Anchor Island with the drawing of the sturdy wharf in the State Archives leaves no doubt that there are close similarities in construction, and that taken overall it belongs to the same type of wharf. The dimensions of the timber are almost the same, although the support posts at Anchor Island seem slightly stouter. The bulwark posts are placed at the same distance from the storm posts — 3.30m (Figs 7, 9). The inner construction also shows many similar features. Both structures have three rows of support posts, with slanting posts in the second and third rows, and stretchers lying across the support posts in Rows 2 and 3. The distance between the support posts and the stretchers and anchors is not exactly the same — it is less at Anchor Island; but the main lines of the structure are the same. There are, however, a few significant points where the Anchor Island wharf differs from the drawing. Above Row 1 of the support posts at Anchor Island there is a piece of stretcher-timber, while on the drawing from the State Archives there are only stretchers above Rows 2 and 3 of the support posts. This leads to another significant difference: the bulwark posts on Anchor Island are not directly fixed to the anchors in the inner construction in the manner shown on the drawing in the State Archives. The distance between the anchors on Anchor Island is less than the distance between the bulwark posts. The anchors are therefore fixed unevenly in relation to the bulwark posts, directly on the wall of the wharf, while the bulwark posts and the storm posts are fastened to stretchers that run over the row of posts. This may be the explanation for the stretcher-timber above Row 1. In his summary of the construction of wooden wharfs of the Hamburg type, Møller draws attention to the fact that ‘the anchor runs in front of the side, both of the wharf and of the storm-post, so that it does not meet them in a timber joint, but is fixed to the storm-post with an iron bolt’.¹³ There is no doubt that the direct connection between the anchors and the bulwark posts/storm posts gives added strength to the construction. Why was this procedure not followed on Anchor Island? The most probable explanation is that at some

It is also interesting to note that the construction drawing for the sturdy wharf in the State Archives shows it standing in about 2m of water. The depth of water prior to the building of Anchor Island was only about 1m; the excavated wharf may have been so solid because a lighter type of wharf had been rejected. The drawing shows that the latter had been used for joining the old Anchor Island to Ballast Island but, according to the note added to the drawing, it had not lasted.

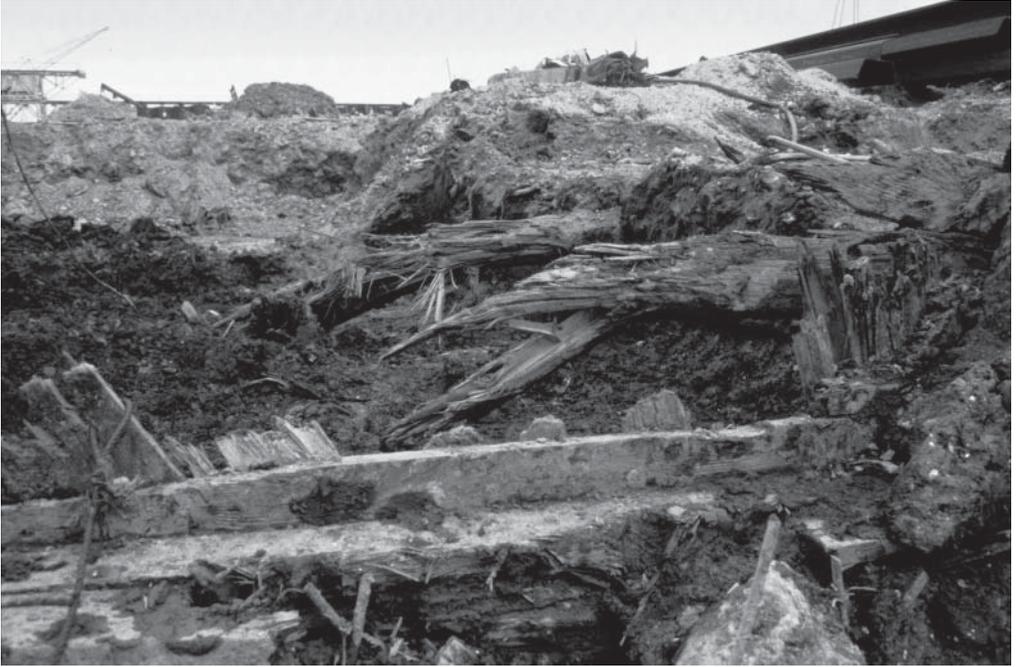
FIG. 4

Anchor Island, Copenhagen, showing the extent of damage before the archaeological investigation began (photograph, Vivi Lena Andersen, Copenhagen City Museum).

The construction work for the Opera House affected the south-western part of Anchor Island. When archaeological work on the site started, large parts of the upper structural timbers of the island had already been dug away (Figs 4–5). Excavation then continued to expose the rest of the wharf in order to gain an overview of the way it had been built. The island was measured by a surveyor using System 34, the official coordinate system used in Denmark for geographical reference; the timberwork was recorded in plan and with selected sections at the scale 1:20. In addition, Lars Nissen surveyed the area with a metal detector and found many metal objects. Once the individual structural components had been recorded, a section was dug through the island from south to north to ensure that there were no sunken ships under it.

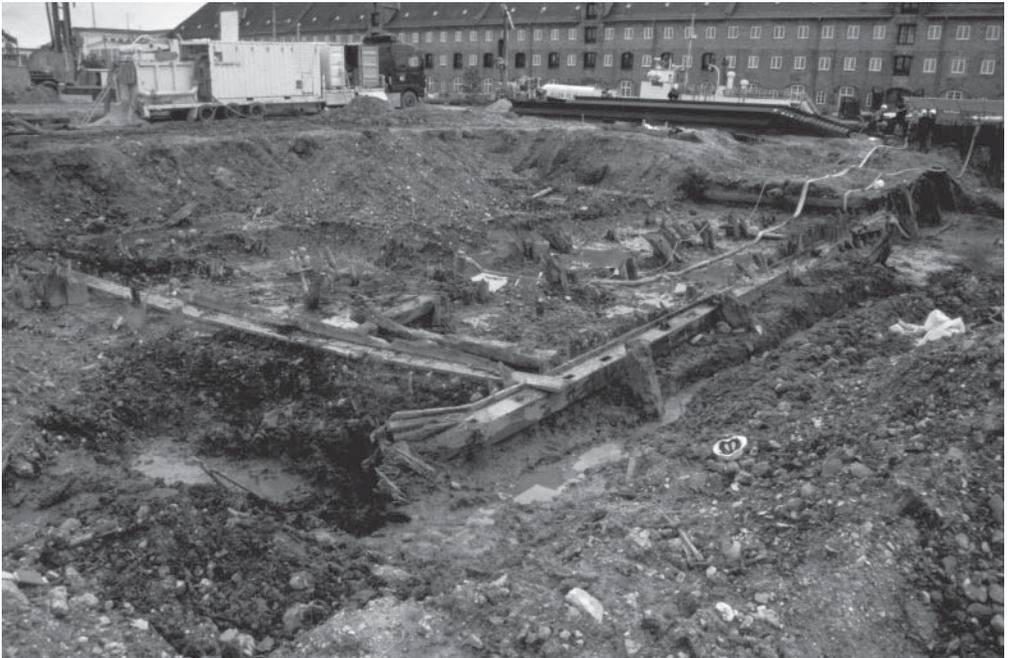
FIG. 5

Anchor Island, Copenhagen: the island seen from the south-west (photograph, Vivi Lena Andersen, Copenhagen City Museum).

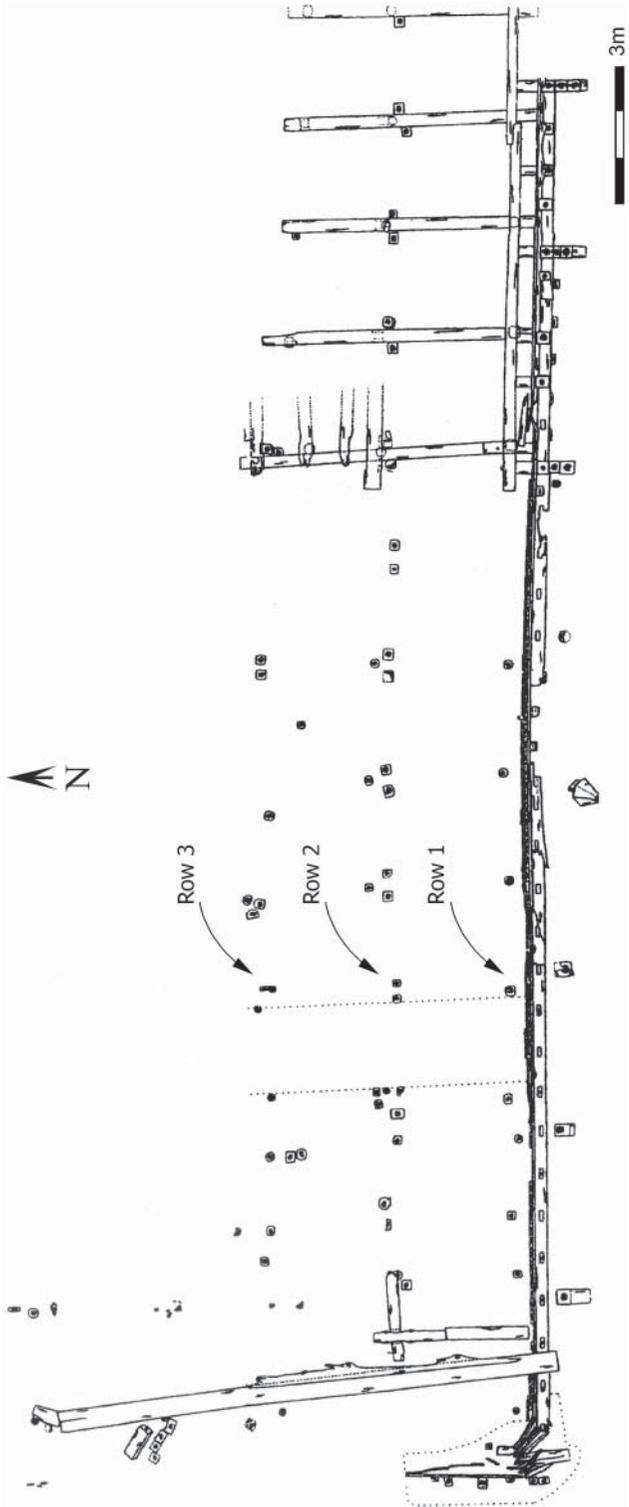
FIG. 6
Anchor Island, Copenhagen: ground plan of the wharf.

The harbour is not tidal. As the timbers were preserved to only just above sea level, no archaeological evidence survives about the upper parts of the structure. Although the lower parts of the wharf had been badly damaged by machine excavation, most of the significant information they might provide could still be recovered (Fig. 6).

the wharf were pile-driven into the sea bed; they consisted of three rows of posts, arranged parallel to the wharf (Fig. 6, Rows 1–3). The bases of some of these posts were seen in a test trench; they stood about 3m high. These uprights will be called support posts; their tops were at about sea level. The row of posts nearest the wharf had been used to build up the wall of the wharf (Fig. 6, Row 1). The second row (Fig. 6, Row 2) lay *c.* 2.90m from the first; the third (Fig. 6, Row 3) stood about 2m from Row 2 at the eastern end of the wharf and 3.20m from the western end. The posts were *c.* 0.26m thick. Above them, at right-angles to the wharf, long anchor beams had been morticed into them; they were *c.* 5.70m long and 0.28m wide (Fig. 7: b). Following their installation, posts slanting away from the wall of the wharf had been driven down at an angle of about 75 degrees on both sides of each anchor, beside each of the posts in support-post rows 2 and 3 (Fig. 7: c). These were *c.* 0.26m wide; their function was to strengthen the anchoring of the wall of the wharf. Next, three rows of cross-beams known as stretchers (Fig. 7: d1–d3) had been laid at right-angles to the anchors and directly on top of the rows of support posts 1–3. The stretchers had been placed so that the slanting posts rested on them; it is therefore difficult to say whether the stretchers or the slanting posts had been put in position first. The wall of the wharf extended *c.* 0.40m in front of the stretcher which overlaid Row 1 of the support posts (Fig. 7: d1). This wall had been fixed to the stretcher with iron bolts running through wooden blocks (Fig. 7: e), and had been made by driving down posts (Fig. 7: f), at intervals of *c.* 3.30m, staggered in relation to the anchors. These posts, known as bulwark posts, were *c.* 0.26m wide. Slanting storm posts, also *c.* 0.26m wide, had been mounted on the bulwark posts (Fig. 7: g). The storm posts had the same function as the slanting posts, preventing the wharf from slipping out of position. They had been fixed to the stretchers with long metal bolts that ran through the first row of posts (Fig. 7: h). The wharf wall was fastened between the bulwark posts and the storm posts. It was constructed of cross-beams known as battens, placed between the driven posts (Fig. 7: i). The lowest battens presumably lay on the seabed. The next would have been about 1m above that; between them were vertical posts, *c.* 0.26m thick, morticed in and spaced 0.50–0.70m apart (Fig. 7: k). On the back of this frame was fastened a cladding which consisted of horizontally placed boards *c.* 0.40m wide and *c.* 60mm thick. Upon completion of the structure, its visible parts would have been the storm posts, the battens, the vertical timbers and the board cladding behind (Figs 8–10).

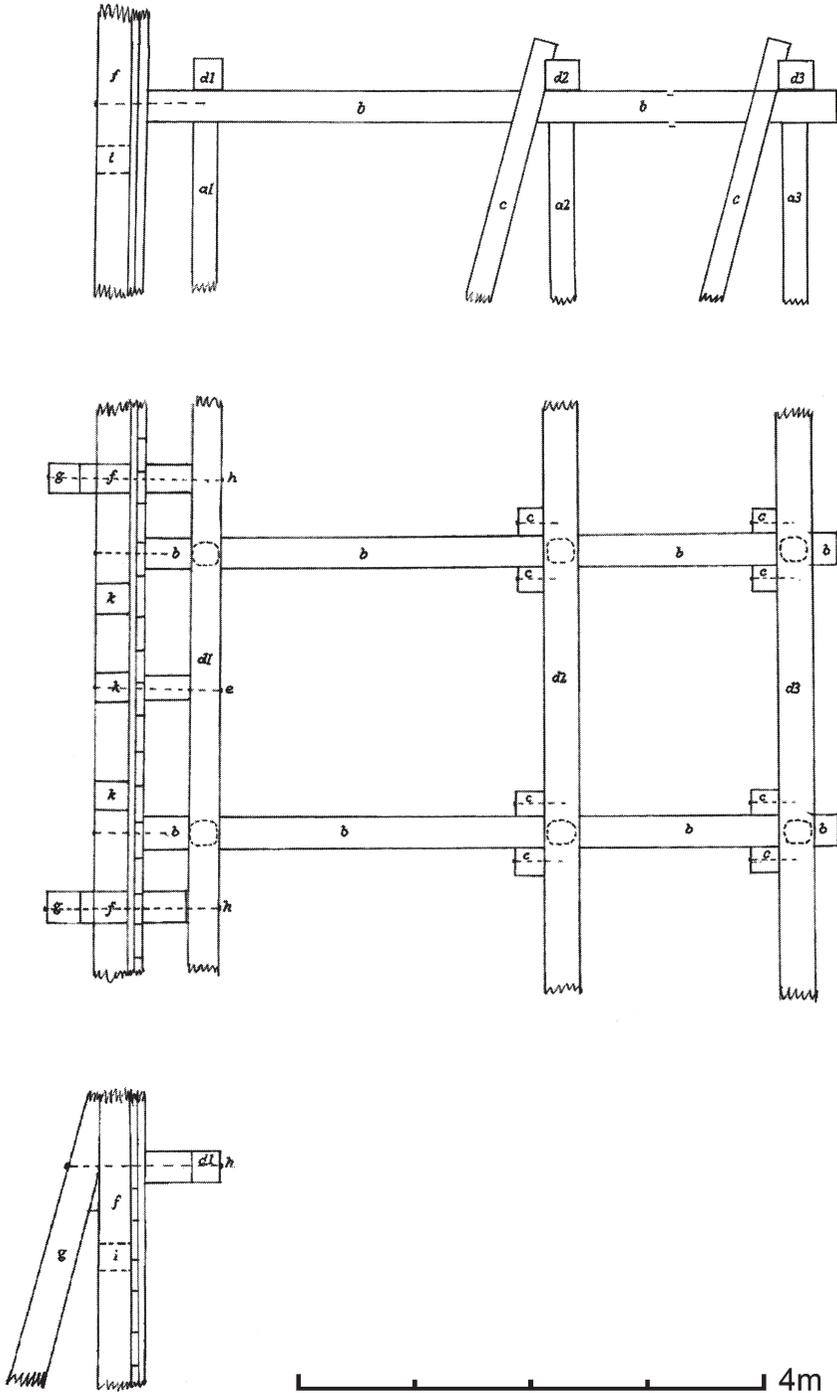
FIG. 7

Anchor Island, Copenhagen: reconstruction drawings of the shape of the wharf in section and plan (drawn by Lene Høst-Madsen, Copenhagen City Museum).

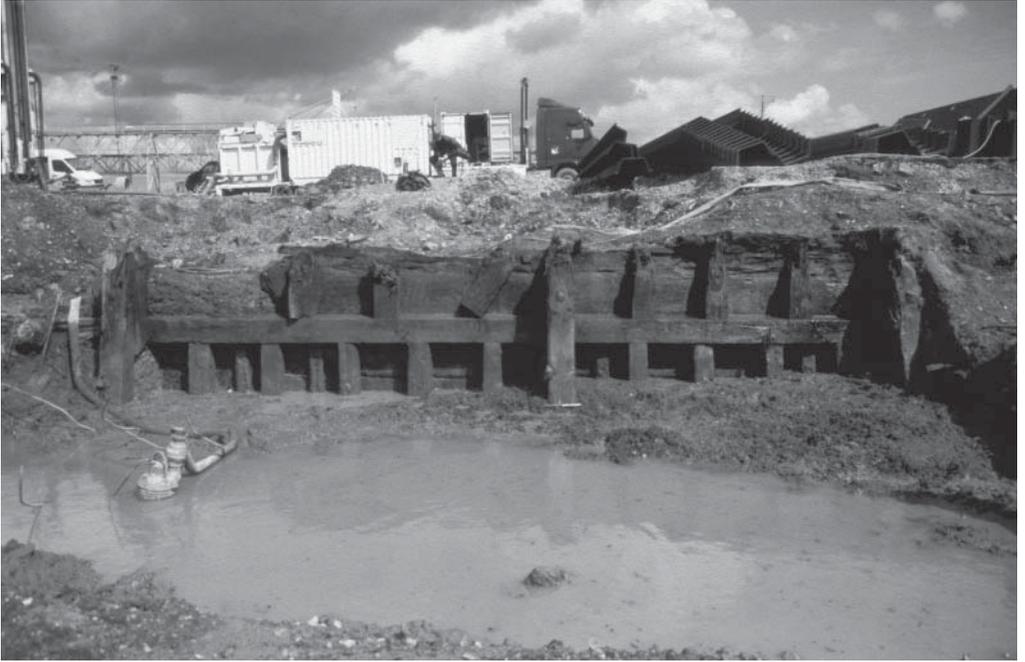
FIG. 8

Anchor Island, Copenhagen: the wharf seen from the south (photograph, Vivi Lena Andersen, Copenhagen City Museum).

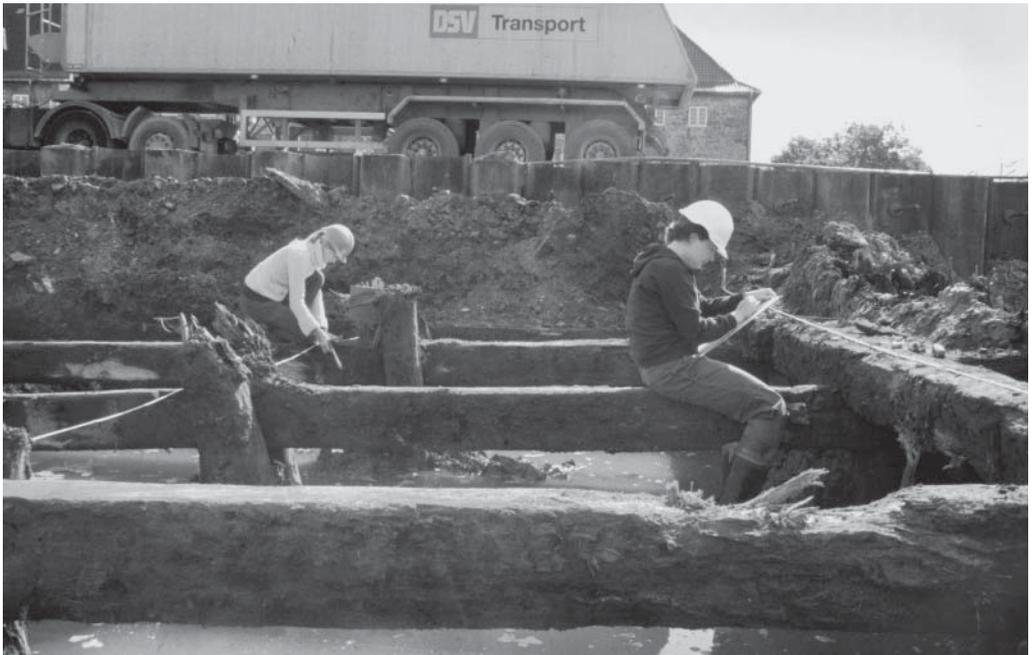
FIG. 9

Anchor Island, Copenhagen: registration of the anchor beams in the inner construction (photograph, Lene Høst-Madsen, Copenhagen City Museum).

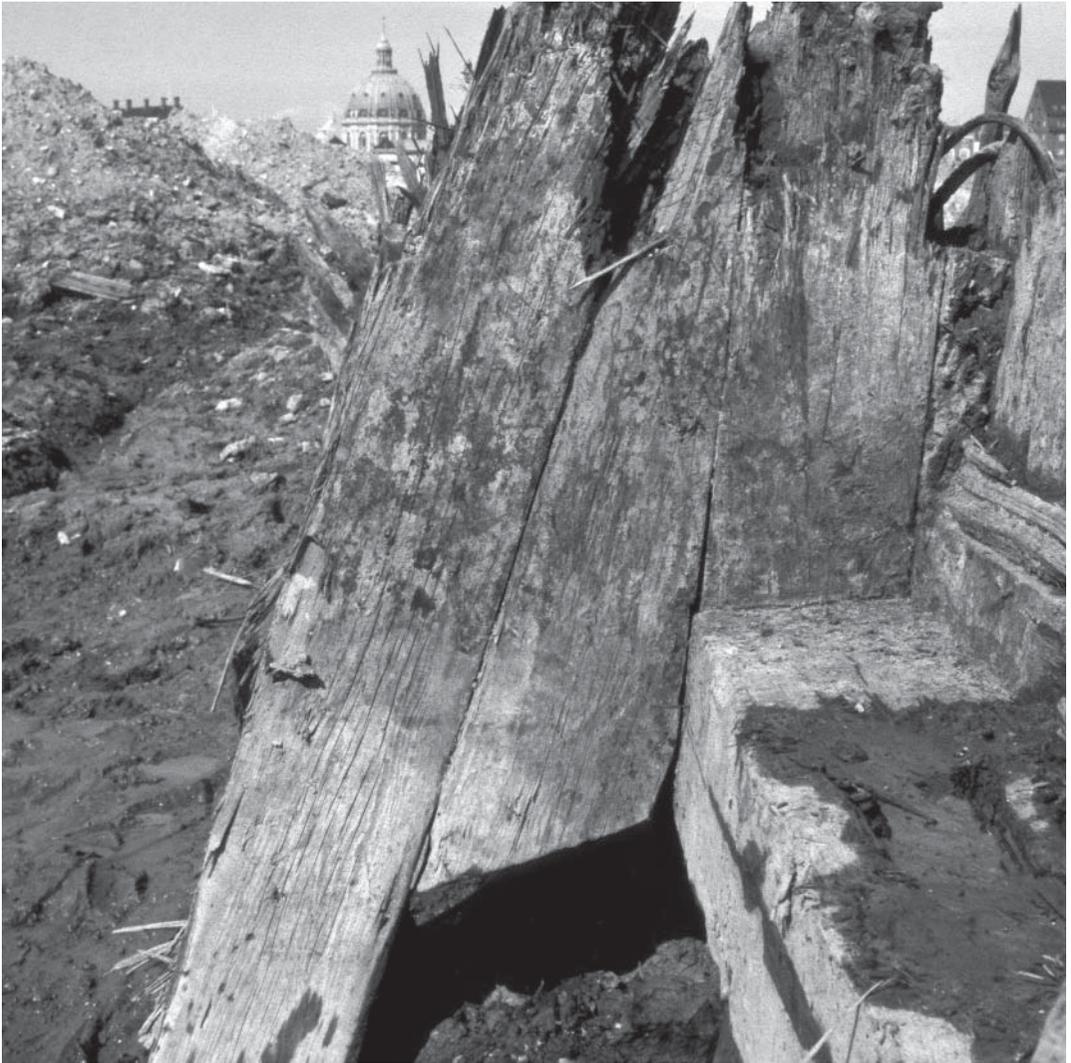
FIG. 10

Anchor Island, Copenhagen: storm post and bulwark post seen from the side (photograph, Vivi Lene Andersen, Copenhagen City Museum).
